CONSERVATION REPORT

THE MELVILLE TOMB, COLLESSIE

Abridged Version

February 2003

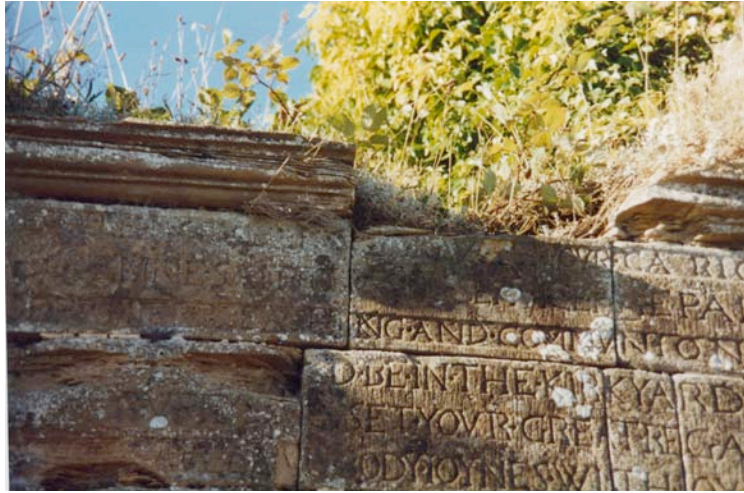
Detail of the inscription

The grey letters indicate text that cannot be discerned today due to the decay of the masonry face. The missing letters are taken from A.H. Millar's recording of it, as published in 1895³. It is however cautionary to note that in the text that is currently legible, A.H. Millar made three errors in his record. Intriguingly, Millar records the date of 1609 above the text. This could only have been located in some missing part of the central heraldic panel.

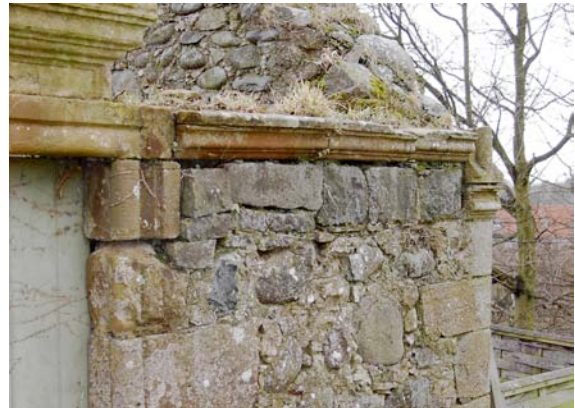
4.2.3 West Wallhead. The head of the west wall has been raised by approximately 240mm. The door lintol was reset on two dressed sandstone quoins, with a moulding similar but not identical to, the moulding on the original quoins, indicating that these were re-used from some other building. Either side, the dressed sandstone capstones were raised onto a new stone of roughly square basalt rubble. The skew put stones were not altered with the result that they no longer align with the cap stones.

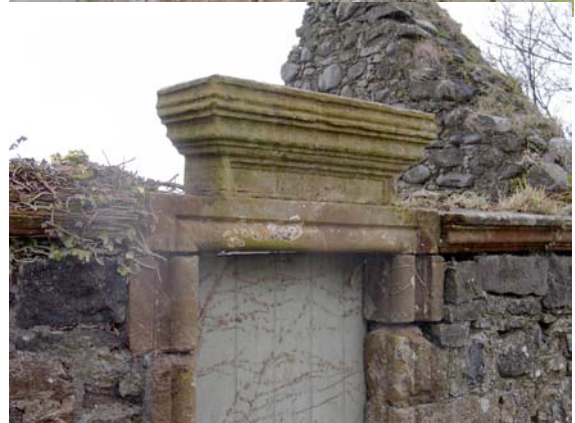
4.2.4 Pediment Stones. On the west wall, above the door, stands a corniced sandstone panel, with the inscription 'Rep'd 1831'. There is a similar stone on the east wall, over the central armorial panel. This stone has no inscription and is raised up on two small rectangular basalt blocks, the rest of the elevation being dressed sandstone. Both these stones have roughly hewn backs and are much more weathered than the others in their vicinity.

- a) Pediment Panels. The two pediment panels will be removed and set aside. After the repairs are completed these will be laid inside the Tomb, where they will be accessible, but protected from the elements.
- b) West Wall Eaves Course. The raised eaves course will be reinstated at its original level, in alignment with the skew putts. This will involve the removal of the 19th C. basalt rubble course and the two door quoins.
- c) Window Infill. The rubble infill to the south gable window will be removed.
- d) Door. The inappropriately designed 19th c. door will be removed, though the ironmongery will be retained for possible re-use.
- e) Possible Soil Infill. A small test hole will be excavated to determine whether the original floor was at a lower level. If this is the case the infill soil will be removed and the original floor conserved as appropriate.

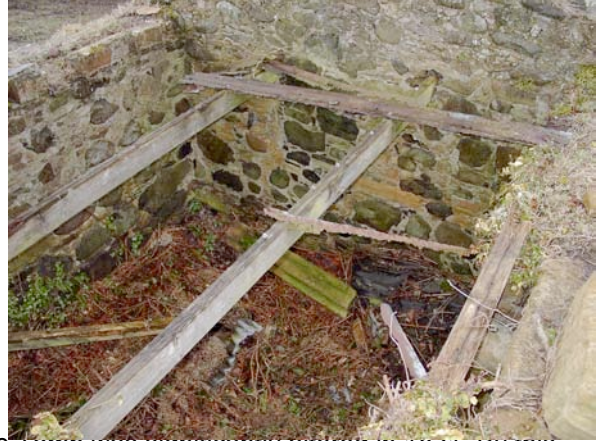
4.2.7 Summary. It is reasonable to surmise that the Tomb was significantly altered in 1831. By this time it would have been disused for some time and, unmaintained, the original roof may have collapsed and windows and door deteriorated. A package of works could have been undertaken to change the ruinous and abandoned building into a useful graveyard store. The low entry was raised, the floor brought to a level and the windows infilled. Two ornate stones, which were probably a part of some other redundant graveyard feature, were relocated to give the tomb a more picturesque appearance.

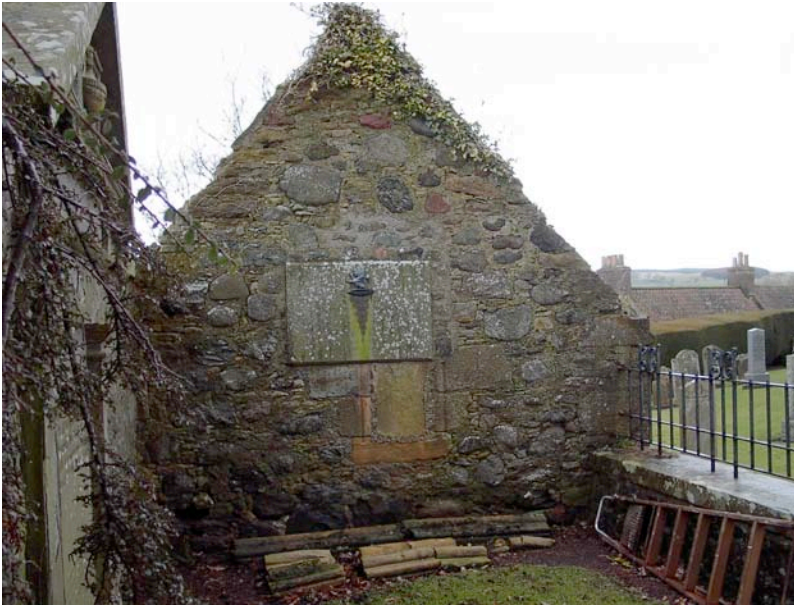
- 4.3.1 North Gable. The north gable is of rubble construction, which is in reasonably good condition on both sides, though minor local repairs are required. The wall head is exposed, with the original moulded skew stones having been removed, some of which are lying at the foot of the wall. Some of these are broken or have suffered other damage. The unprotected wallhead allows ingress of water and this has encouraged vigorous growth of ivy and other vegetation, growing from inside the Tomb. The ground level has been raised, meaning that the wall is partly retaining, leading to damp also at low level. The original window had sandstone roll moulded quoins and has a flush infill of basalt rubble in lime mortar. On top of this, a funerary plaque has been inserted, dated 1935, damaging the lintol and some quoins.

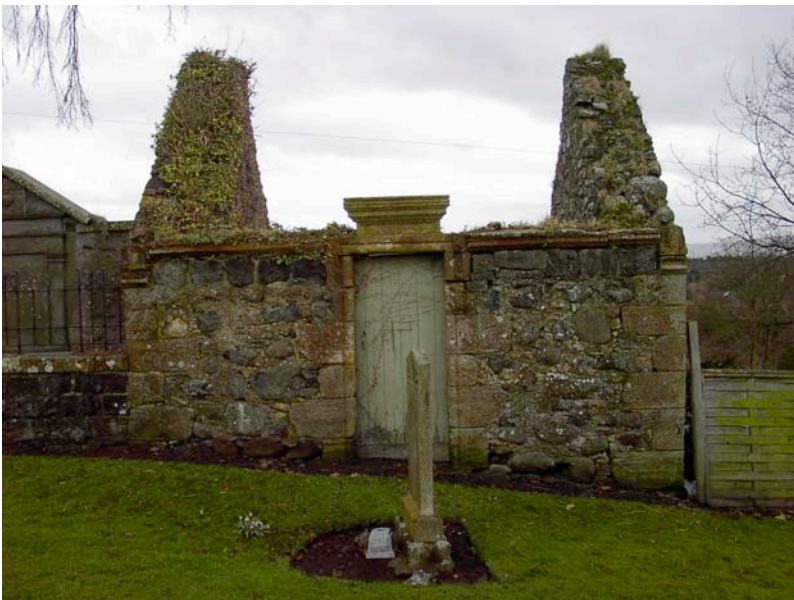
- 4.3.2 West Wall. The west entrance wall is of rubble construction with sandstone dressings. The raised wall head is exposed, allowing ingress of moisture and supporting vegetation growth. The moulded sandstone eaves course stones are suffering locally severe delamination due to moisture ingress and vegetation growth. The rubble is in reasonable condition on both faces, though the original flush face has been lost. The door is a modified boarded and ledged pine door, painted green and with 2 iron strap hinges and a timber boxed mortice lock. The timber work is in poor condition, but the ironmongery could be refurbished.

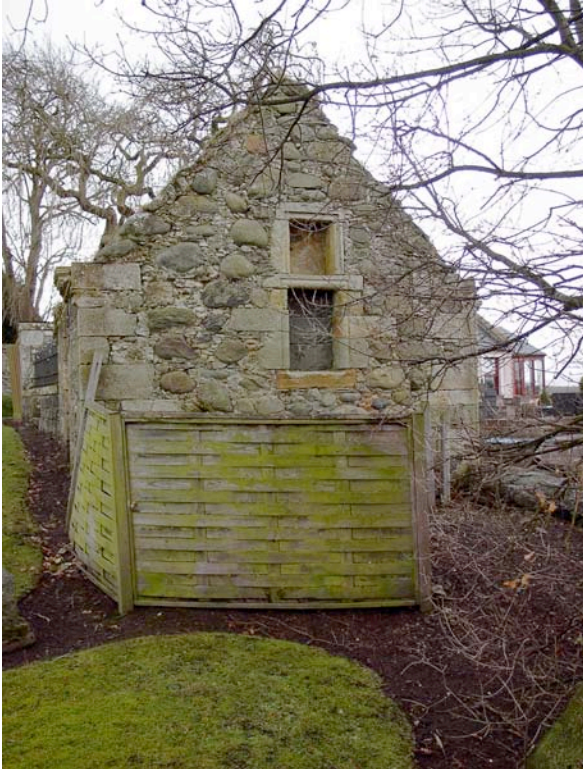
4.3.3 South Gable. The south wall is of rubble construction with sandstone dressings. The rubble work is in reasonable condition, though there is one rodent hole at ground level and the original flush face has been lost. The wall head is exposed, with the original moulded skew stones having been removed, one of which is lying inside the Tomb. The unprotected wallhead allows ingress of water and this has encouraged growth of vegetation. The window opening has sandstone roll moulded quoins and has a recessed infill of basalt rubble in lime mortar. On top of this there is a sandstone dressed niche, presumably for an armorial panel, which has been lost. A timber enclosure fence to the compost heap has been nailed to the joints in the sandstone quoins.

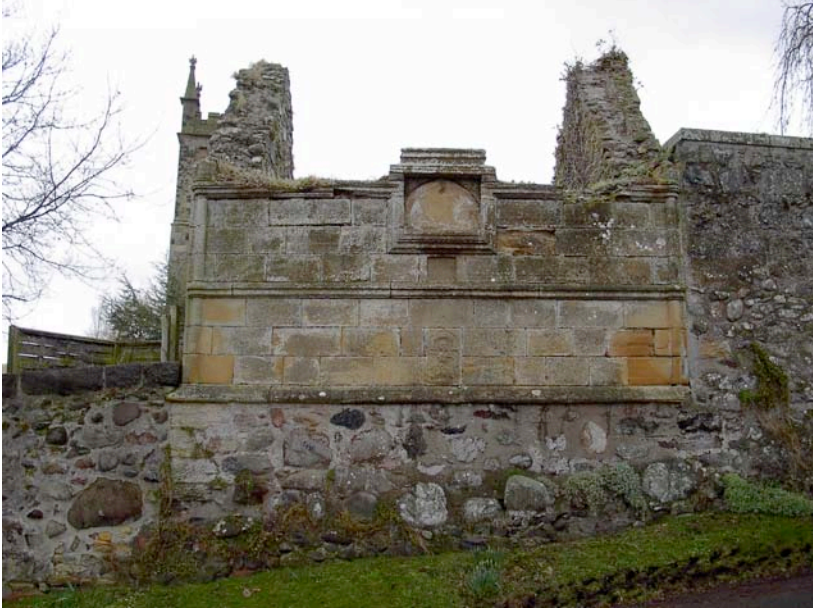
The upper panel, of similar ashlar, sits on a moulded string course and has an extensive Scots text incised in the upper three courses. It has a central recess for an armorial panel, though only traces remain of a heraldic shield and more complex side mouldings. The panel is surmounted by a moulded pediment panel. This panel is considerably more worn than the other masonry and is mounted on two basalt blocks, both indicating that it is not part of the original design. Below the armorial panel there is a small undecorated square recess. The wall is framed by clasped, half round pilasters which run into the skew putt mouldings. The wall is capped by a moulded eaves course, which matches that on the west wall.

This wall has benefited from facing away from the prevailing winds. Much of the text is still sharp, though there is locally severe loss on certain stones due to delamination and the effects of algae and lichen. Mortar joints are generally open. There is some loss of face from spalling due to moisture movement from the retained ground on the north side of the lower panel. The wall head is thoroughly colonised by ivy and other vegetation, with deterioration of the stone mouldings, primarily delamination, quite advanced. One stone is completely missing. The steady deterioration of this important and vulnerable wall is evidenced by the accumulation of small sandstone debris at its base.

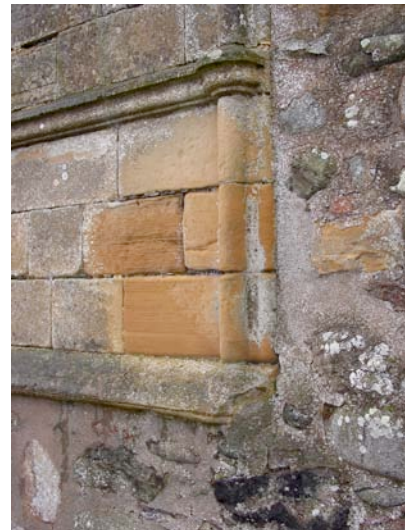
- a) Damp Movement. The lack of a roof over the earth floor, the raised ground in the Rossie burial enclosure and the cement pointing to the adjacent rubble all contribute to the movement of moisture through the masonry, particularly the ashlar faced east wall. This mechanism brings salts to the surface of the stone, causing spalling. The salts also push iron staining to the surface of the stone.

This decay is most evident in the right side of the lower panel, where there is most retained ground and adjacent cement pointing.

To address this decay mechanism, the retained ground should be removed or drainage improved, where possible. The cement pointing should be removed and replaced with a lime mortar pointing.

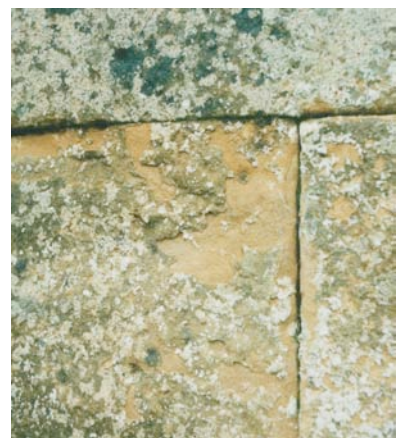
- b) Lichen Growth. The high moisture levels in the walls, caused by the damp movement described above, as well as the exposed wallheads and open joints, creates an environment for organic growth. The growth of lichen on the surface of the stones is particularly apparent on the east ashlar wall. The lichen holds acidic moisture in the surface of the stone, causing decay of the face. It also obscures the lettered text.

The moist environment which encourages lichen growth will be reduced by removing the retained ground moisture pressure, removing the cement pointing, filling open joints with lime pointing and stopping rainwater penetrating the wallhead.

The existing lichen will be lightly sprayed with an approved biocide and left to die off. The dead lichen will then be removed with a dental steam machine, carefully worked over each surface and controlled to as not to over clean the stone.

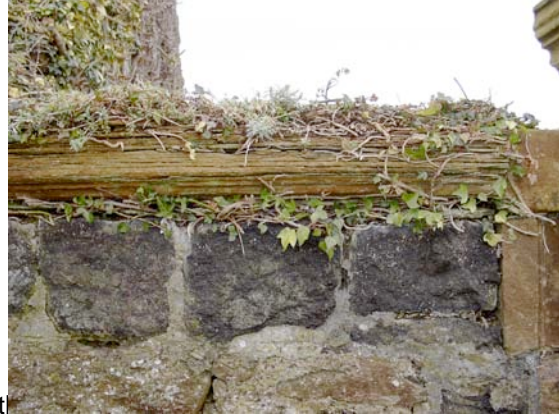
- c) Delamination. The high moisture levels in the walls has led to the leaching out of some of the clay content of the stone, weakening the bond between the minerals. This has exposed the natural bed of the stones, particularly the moulded eaves stones. Once established, this delamination has allowed organic growth to penetrate the natural beds and break the cohesion of the stone.

The existing vegetation will be lightly sprayed with an approved biocide and left to die off. The dead vegetation will then be removed carefully by hand. Stones will be repaired with lime mortar, where possible, or replaced with new stones, dressed to match, where the originals have lost all cohesion.

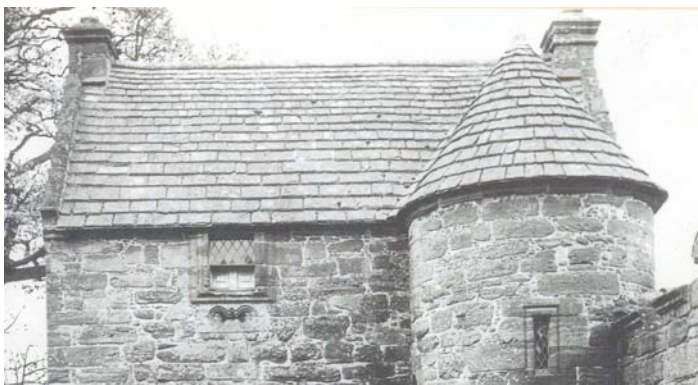
The Summer House at Edzell Castle is dated 1604 and displays a typical stone slated roof, leaded windows and oak boarded door.
